Urban Search and Rescue and Rapid Field Assessment of Damaged and Collapsed Building Structures

Abid I. Abu-Tair, Gavin M. Wilde, John M. Kinuthia

Abstract—Urban Search and Rescue (USAR) is a functional capability that has been developed to allow the United Kingdom Fire and Rescue Service to deal with ‘major incidents’ primarily involving structural collapse. The nature of the work undertaken by USAR means that staying out of a damaged or collapsed building structure is not usually an option for search and rescue personnel. As a result there is always a risk that they themselves could become victims. For this paper, a systematic and investigative review using desk research was undertaken to explore the role which structural engineering can play in assisting search and rescue personnel to conduct structural assessments when in the field. The focus is on how search and rescue personnel can assess damaged and collapsed building structures, not just in terms of structural damage that may be countered, but also in relation to structural stability. Natural disasters, accidental emergencies, acts of terrorism and other extreme events can vary significantly in nature and ferocity, and ca

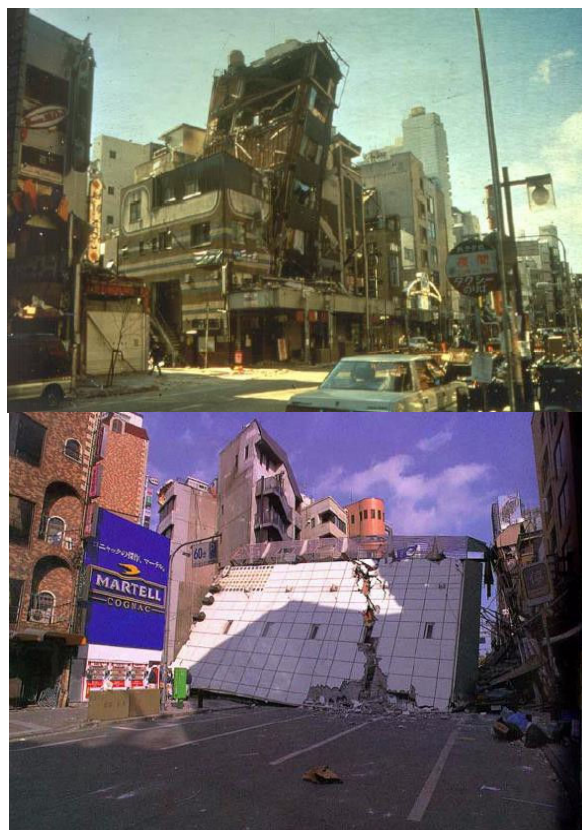
Fig. 3 Example of damage witnessed after the 1995 Kobe, Japan earthquake (a) An unstable building structure [1]. (b) An unstable building structure which collapsed less than 24 hours after the original earthquake [1]

may have collapsed and others may have become unstable which could collapse at anytime, see Fig. 3.

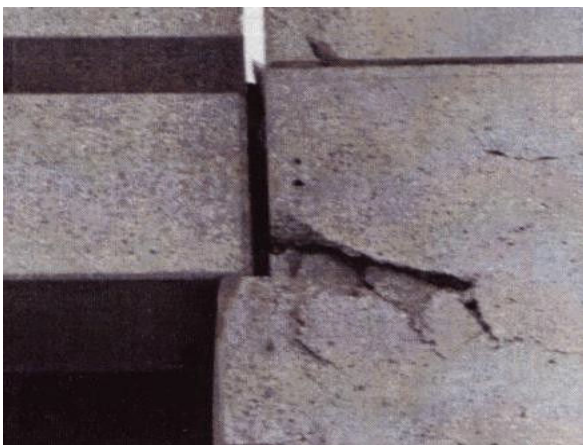
Fig. 8 Example of cracking of a precast concrete support of a parking structure documented in the ATC-20 series [29]

A notable feature of the ATC-20 series is the frequent use of diagrams and photographs as visual aids to emphasise guidelines and procedures, and to illustrate what to look for during visual inspections. Throughout the ATC-20 series it states that a considerable amount of judgment is required to assess damaged building structures and it is very difficult, if not impossible, to develop damage evaluation procedures and guidelines that can be used without judgment. To help those undertaking the tasks of assessing and classifying damage to building structures following an earthquake, photographs have been included throughout the ATC-20 series to document the different types and varying extent of damage, see Figs. 6-9.
